An Introduction to the Lizard NDE Technology

An Overview of the Lizard NDE Technology

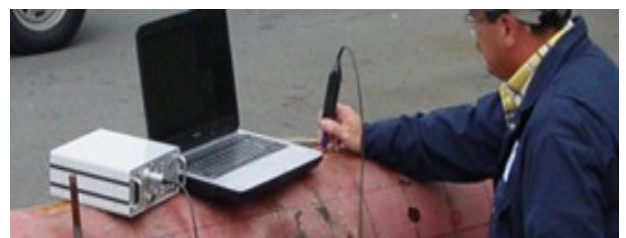
The Lizard M8 in use performing an inspection through a protective coating

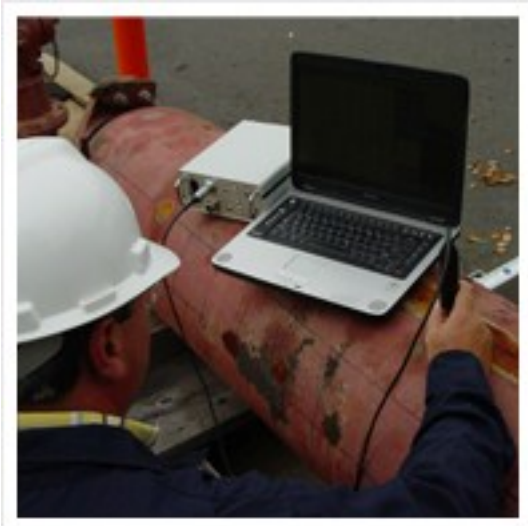
Standard Inspection using the Lizard® M8 and LP600 Lizard Probe

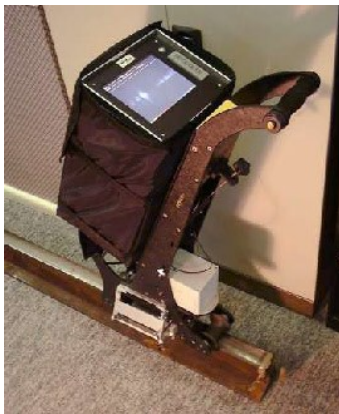
Lizard® FGI Pedestrian Unit for the Inspection of Rail

Following further development works the Lizard® technology was further refined with the invention of the Lizard® Field Gradient Imaging (FGI) technology. Using this unique technology the Lizard® was adopted by the UK rail network for the detection of rolling contact fatigue on plain rail and points and crossings in addition to applications for railway freight and passenger vehicles with Alstom Transport. Following a major review linked with a derailment of a passenger train and loss of life the technology was chosen to free up the rail network from consequent speed restrictions imposed by HMRI (Her Majesty's Railway Inspectorate).

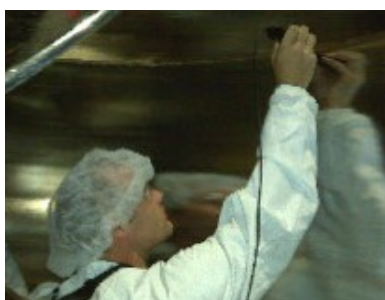
Stainless Steel Pharmaceutical tank inspection using standard Lizard® probe arrays

After receiving a request from the world's largest NDT inspection company Lizard® was tasked to provide enabling technology and procedures for the inspection of product reactor vessels within a pharmaceutical plant such that non-ferrous inspections could be performed to detect stress corrosion cracking in stainless vessels without any external contamination. This application was extremely successful and enabled significant downtime of the asset.

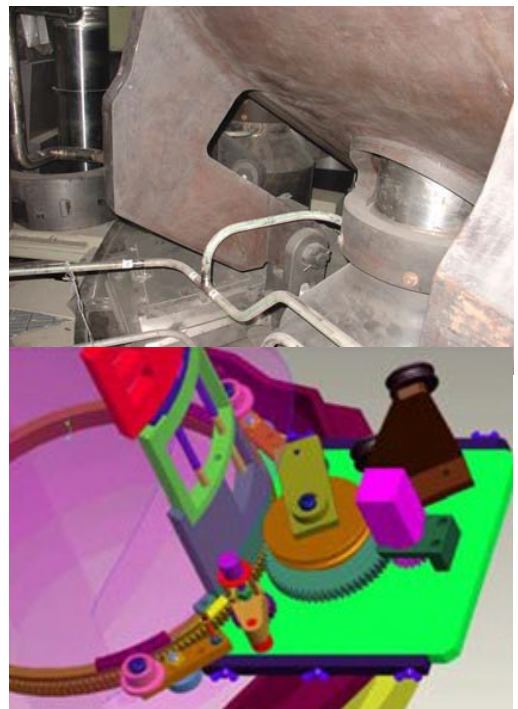
Nuclear PWR application and CAD presentation of robotically deployed Lizard® array

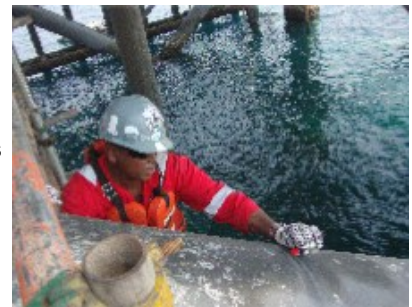
Offshore rope access inspections performed using the Lizard® M8 NDE System

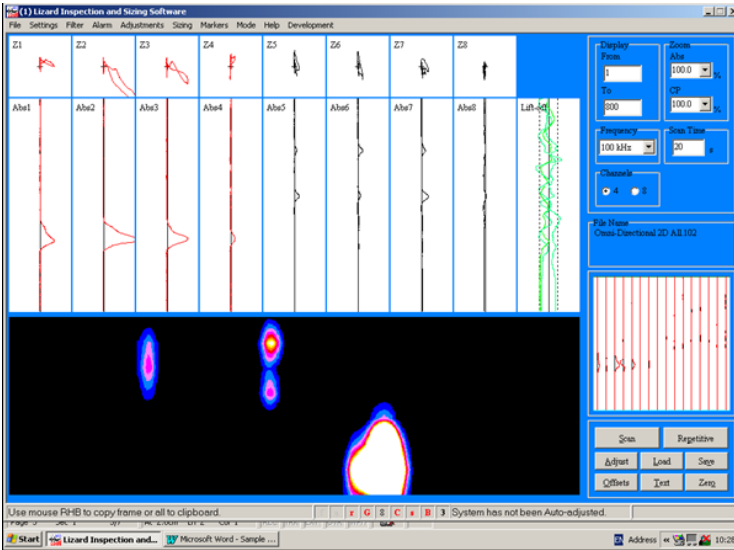
Lizard® FGI display of defect data obtained using the Lizard® Versatile Array system for the inspection of mixed metal alloy welds

Following requests from industry and premier government research laboratories Lizard® developed custom arrays for the inspection of critical components within the Nuclear reactor system. The Lizard® technology evolved into the Versatile Array range of product having the capability to steer the sensitivity of the inspection arrays by excitation controlled by computer and software. This provides an excitation and detection capability ranging from linear through transverse and omni-directional to a scanning direction. In addition multi arrays can be operated separately and independently such that each array can interrogate differing metal compositions during a robotic or manual scanning regime. The Lizard® Versatile Array technology is implemented within two separate arrays which can be scanned together in tandem with other technologies, such as phased array ultrasonics. This gives a full volumetric inspection capability which when coupled with a robotic manipulator allows the full inspection of critical components remotely. In addition differing versatile arrays can be targeted through software to provide for the capability of inspecting differing metal alloys (ferrous and non-ferrous) in a single pass.

This capability lends itself to the nuclear industry where it is common to have mixed metal welding and non-ferrous cladding with defects that can grow into dissimilar metal to metal regimes. In particular where thermal quench fatigue conditions are present defects may be growing in mixed weld material and propagating to clad areas or growing in one or the other of these regions independently. Since these are surface fatigue events they are difficult to confirm the detection of them with ultrasonics. However in addition to a versatile array sensor package a phased array ultrasonic inspection regime can be accommodated such that both technologies offer the best and most appropriate approach.

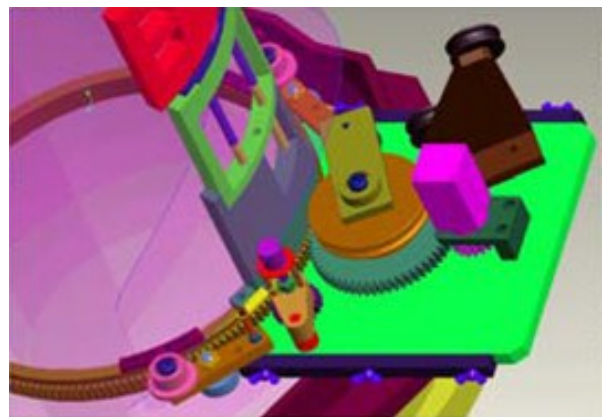
CAD image of the robotic manipulator used for the automated scanning of the Lizard Versatile Array sensor. The Lizard's ability to utilise two dimensional array configurations were essential to the application due to the access limitations on site

- Lizard has had a close relationship with a Government research institute who have been utilising the Lizard® M8 and multi-mode software to explore solutions to inspection requirements within the Nuclear industry that were critical and required novel non-destructive testing methods and robotic access to provide a high quality integrity assessment of certain nuclear reactor components for a PWR on site nuclear power generation facility. Full size components were exposed to thermal fatigue and stressing such as to generate laboratory samples having a spectrum of locations and sizes of fatigue defects at sites of cladding of parent plate and at non-ferrous alloy profile ground welds. Laboratory tests using the Lizard® M8 and a range of field gradient and classic probes provided information and assurance of the technology and form of Versatile Array that could be deployed with a robotic scanner. The unique technology of the Versatile Array enabled the construction of arrays contained within an extremely thin section to accommodate the access between the target structure for inspection and the nozzle wall giving Field Gradient image capability of defect depth and length. In order to ensure that cross checking and additional confirmation could be provided the Lizard® technology was combined with phased array ultrasonics in a composite system with Lizard® providing additional control of the robotic scanning software. The Versatile Array and phased array ultrasonics operated in conjunction with data being transmitted through a two wire link to the scan controller and host data capture and analysis hardware sited hundreds of metres away from the inspection site. The program was completed successfully and additional work to further enhance the scanning and presentation of data is planned for the next inspection campaign.

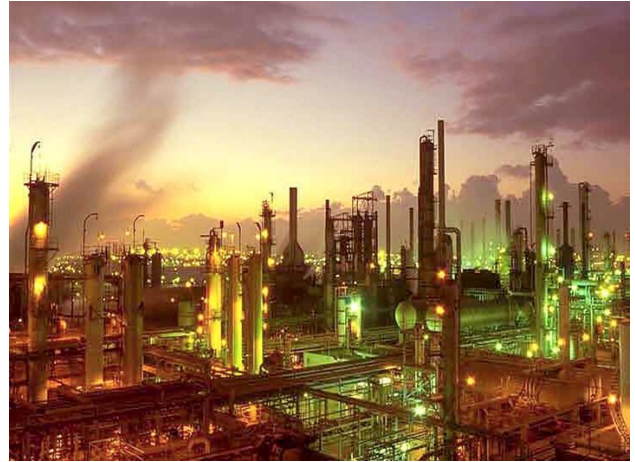
Hydro cracking plant where the principle application is the many internal trays and their attachment to the vessel walls with site welds and remedial grinding

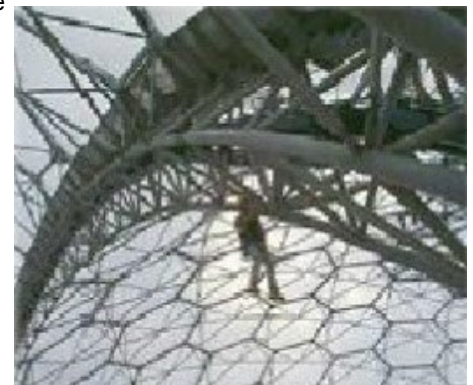
Lizard® inspection of geodetic structure using rope access operators

During construction and site erection of a geodetic structure it was necessary to provide a procedure for determining the presence and extent of possible thermal gradient cracking in geodetic tubulars following hot zinc dip. The Lizard® technology was employed due to the ability to inspect through the zinc coating and provide an omnidirectional array to allow access to critical locations. The procedures and technique was developed in conjunction with one of the UK's premier civil engineering consultancies and deployed on engineering sections and samples to determine the procedure and form of array to provide the necessary capability. Access to the main span was only possible by using skilled rope access engineers with the electronics and data acquisition package attached to the rope access operator for performing the array scanning with data transferred to the remote system operator, data storage and interpretation which was in this case some 200 metres from the inspection site. This campaign enabled the client to have a high level of confidence at very low cost in the structure during the site build and an archive to act as a baseline against future inspection campaigns.

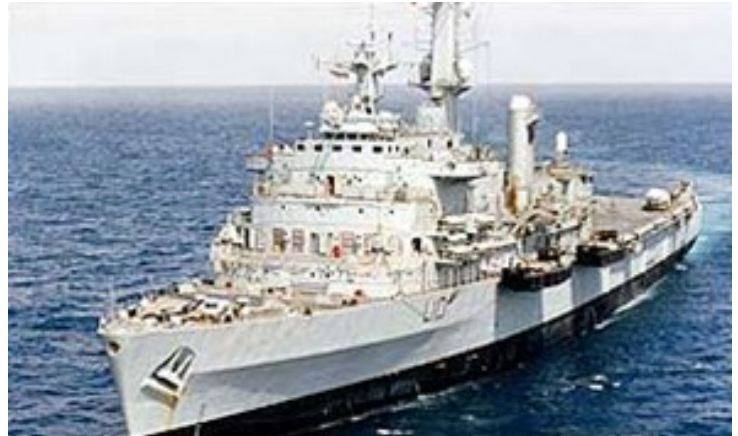
The Lizard technology had been used extensively to extend the operational life of HMS Fearless

As with the oil and gas offshore industry the Ministry of Defence have recognised the advantages of a technology and procedures that can successfully 'see through' protective coatings to at least 8mm thick without the need for any couplant or coating preparation. Typically coatings on submarine tail-shafts consist of protective layers of Denso tape and epoxy composite bandage to at least these thicknesses and in many occasions in a free full compartment. A single array mounted above the coating can therefore inspect the layer of the shaft beneath by simply rotating the shaft. It can even be accomplished along the dock side by intervention of a diver into this space and manually scanning the external protected shaft or component. Lizard® sensors can also be remedially placed in critical locations either in re-fit or during a tour of duty to enable remote acquisition of integrity of specific areas from these electronically scanned foot prints under the arrays.

Tasked by Naval Architects of the Ministry of Defence Lizard® technology was identified as a method of detection and quantifying of corrosion and pitting on the internal wall of the massive diesel tanks for HMS Fearless. The tanks were known to have been biologically infected with a micro-organism under anaerobic conditions that excreted sulphuric acid as a by product leading to severe corrosion on the inner walls of the massive diesel storage tanks, the bottom of which formed the ship's hull. The program had to be capable of delivering the correct data without the requirement to dry-dock the ship. In addition

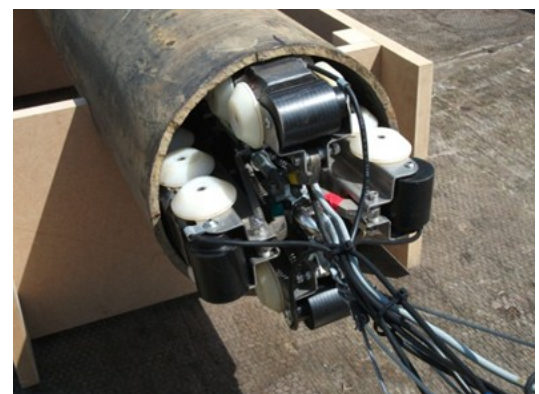
The Lizard® FGI pipe inspection system deployed in a 10 inch pipe for the single pass identification of defects on the inside and outside pipe wall
