Laser Technology Inc.

Model LTI-6200 Portable Thermal Shearography NDT System

Model LTI-6200 Portable Shearography System

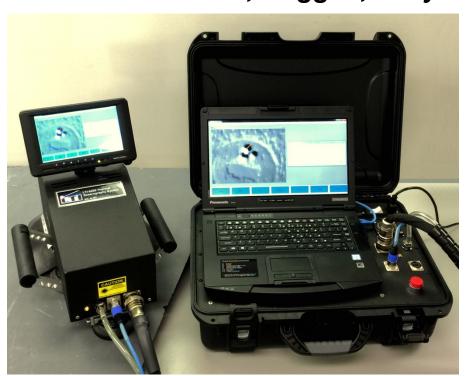
The LTI-6200 is a compact, portable thermal shearography system designed for the nondestructive inspection of aerospace composite repairs, structures and components. The LTI-6200 has a vacuum attach feature to allow operation in any orientation on-aircraft, on panels in the shop or on the bench. The patented cantilevered design allows inspection up to edges and corners on flaps, control surfaces, wing panels or cut-outs. The system features automatic operation with easily SAVE/RECALL NDE Procedure Macros, automatic exposure and image storage. The LTI-6200 includes the Inspection Head, Controller, cable set and transit case.
