Large-Standoff Large-Area Thermography

LASLAT

Developed under SBIR NAVAIR N092-097

Maria Frendberg Beemer
Technical Lead
Thermal Wave Imaging, Inc.

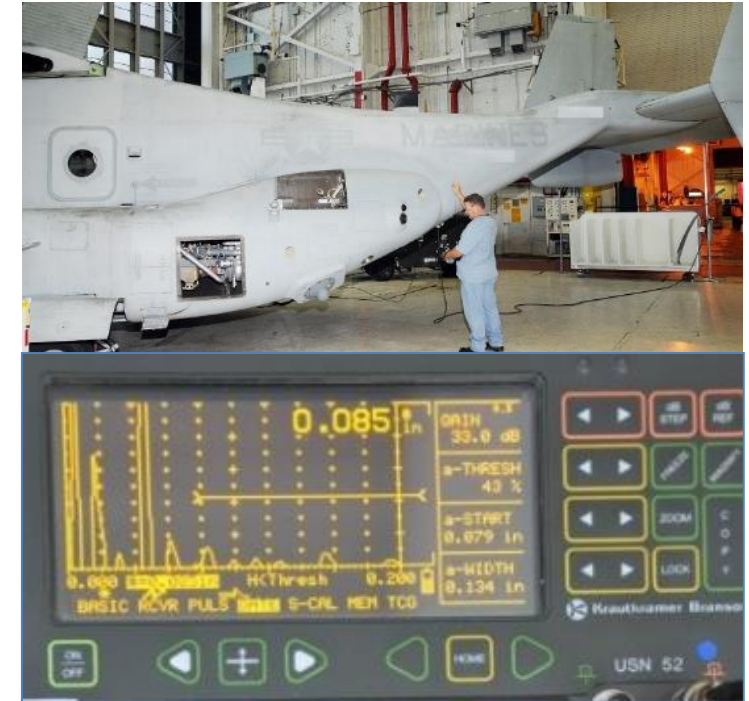
Single-point A-Scan analysis is time consuming and requires experienced operator to interpret signal trace

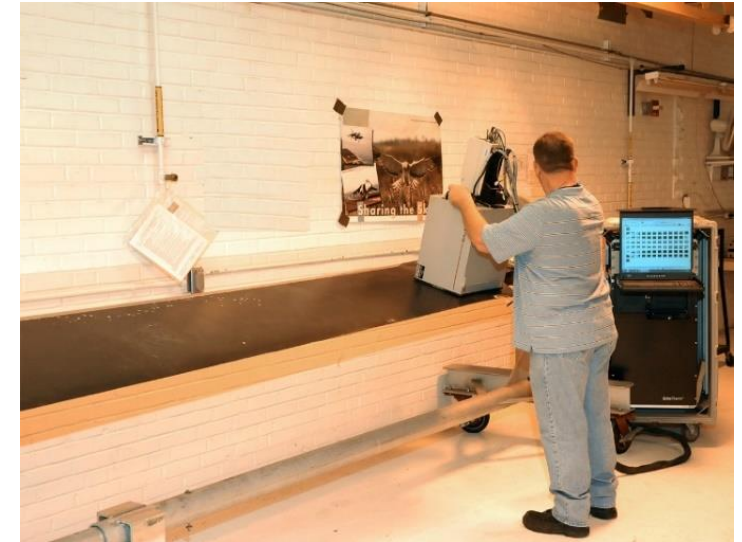
Flash Thermography Inspection
of V-22 Proprotor at FRC-E

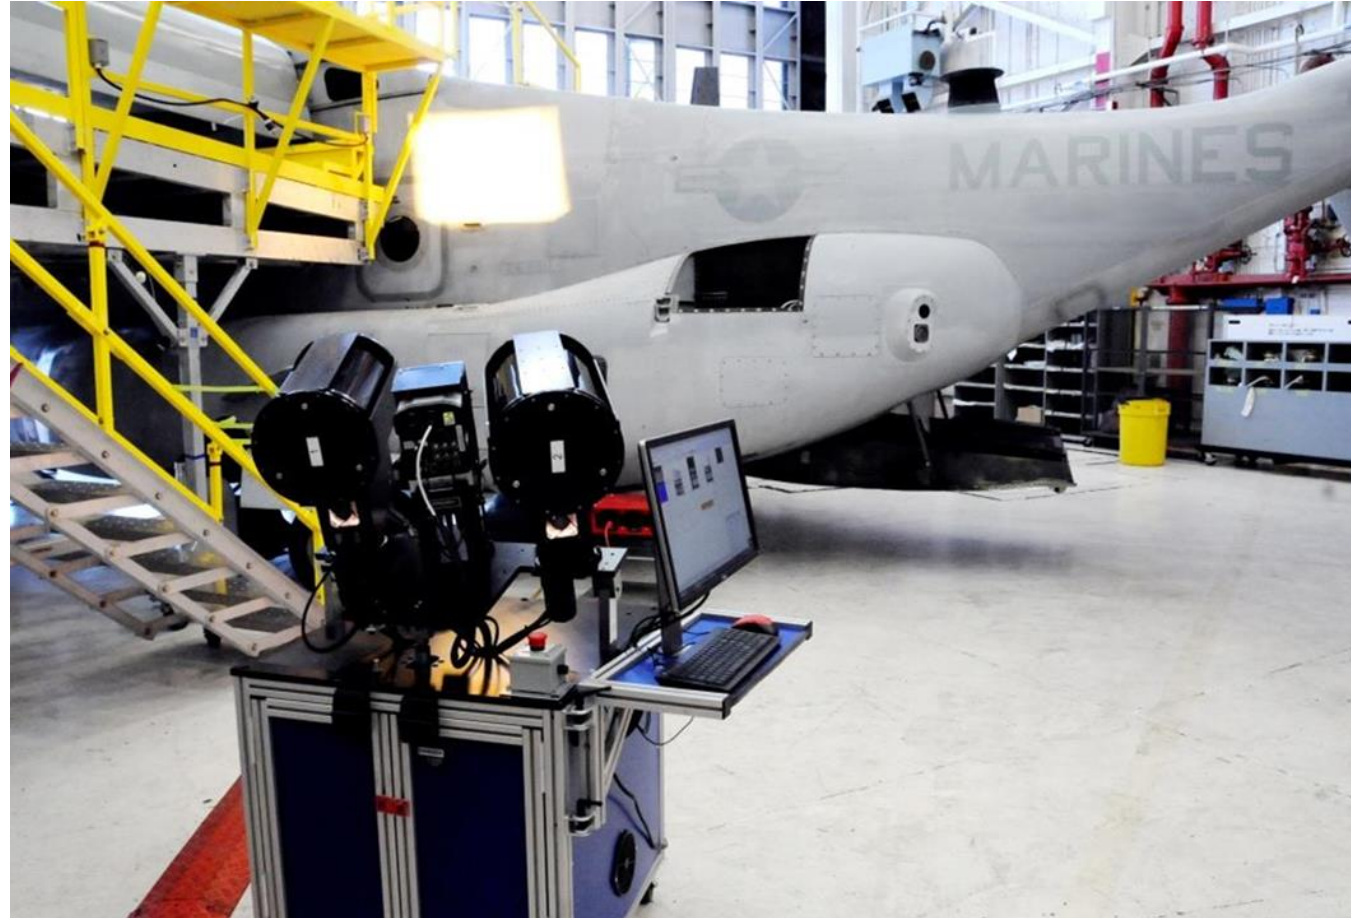
Automated scan of inspection area
